**Flood Control Project Maintenance
Levee Inspections**

Maintenance Issue Types Only, Levee Inspection Report By Mile - Spring 2018

American River Flood Control District

Waterway	Bank	Unit Miles	Inspection Start/End	Inspector
Unit No. 01 Arcade Creek	Left	2.08	05/08/2018 05/08/2018	Sterling York

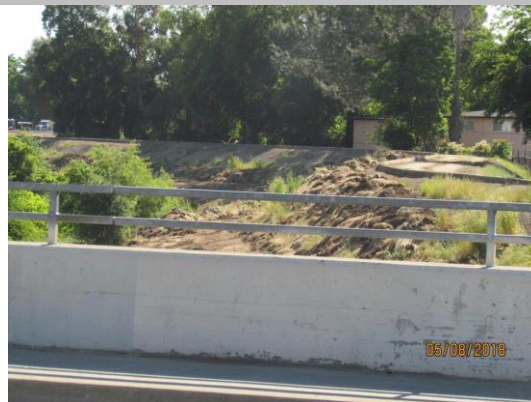
Photo 1 of 1 : SP_2018_NA0001_51_45_20180514_00089.jpg

LM Start	0.02	Rating **	A/W	Issue No.	45
LM End	2.07	Issue Type +	Ma	Location *	
Category	Earthen Levee			GPS Latitude/Longitude	
				Start	End
Item	Crown Surface / Depressions / Rutting			38.619443 °	38.627293 °
				-121.467339 °	-121.432635 °
DWR ID	DWR_NA0001_01_s_2018_45				
Comment Code					
C2 : Repair depressions or ruts in the crown or slope.					
Inspector Comment					
This Unit is under construction and not accessible. All the issues for Unit 1 will have to be reassessed when construction is complete and turn back over to ARFCD to maintain. Spring 2018.

View looking upstream from Norwood Ave. This Unit is under construction and not accessible. All the issues for Unit 1 will have to be reassessed when construction is complete and turn back over to ARFCD to maintain. Spring 2018.

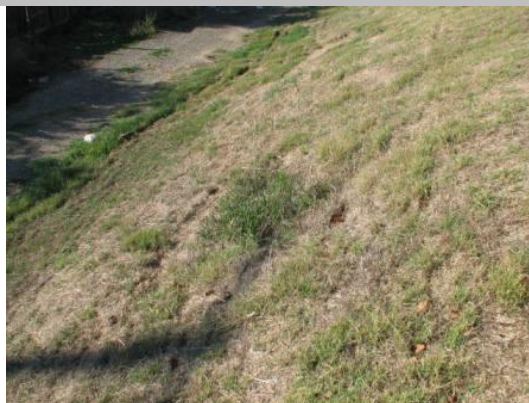
Photo 1 of 2 : SP_2018_NA0001_51_164_20180404_00049.jpg

11/17/2011 Hole/depression approximately mid-slope.

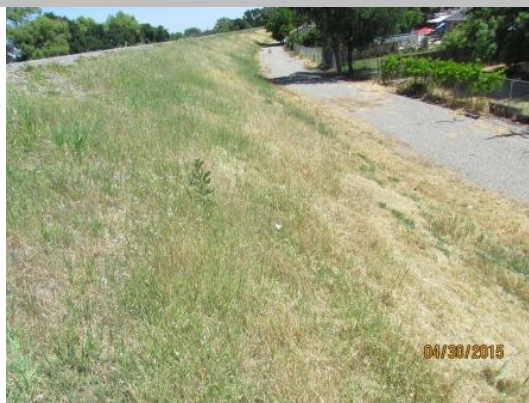
Photo 2 of 2 : SP_2018_NA0001_51_164_20180404_00050.jpg

LM Start	0.48	Rating **	A/W	Issue No.	164 (cont)
LM End	0.48	Issue Type +	Ma	Location *	LS

Another view of the depression on the landside levee slope.

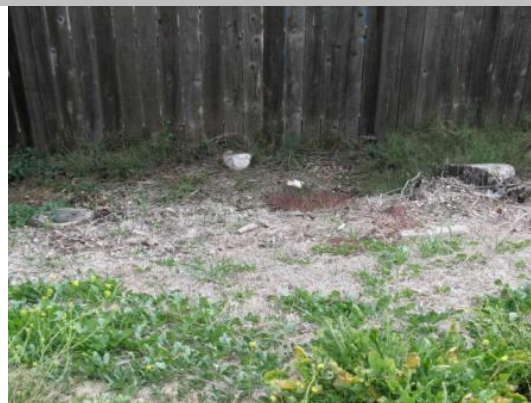
Photo 1 of 1 : SP_2018_NA0001_51_178_20180404_00057.jpg

11/17/2011 Two stumps at levee toe.

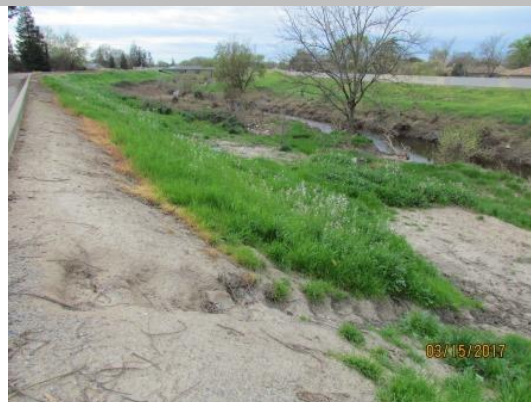
Photo 1 of 1 : SP_2018_NA0001_51_75_20180404_00048.jpg

LM Start	1.48	Rating **	M	Issue No.	75
LM End	1.48	Issue Type +	Ma	Location *	WS
Category	Earthen Levee			GPS Latitude/Longitude	
				Start	End
Item	Slope Stability			38.626912 °	38.626912 °
				-121.443229 °	-121.443229 °
DWR ID	DWR_NA0001_01_s_2017_75				
Comment Code					
S2 : Repair the levee slope damaged by foot traffic and prevent access where possible.					
Inspector Comment					
Stairs dug into waterside levee slope.

View of the stairs in the levee slope, looking downstream.

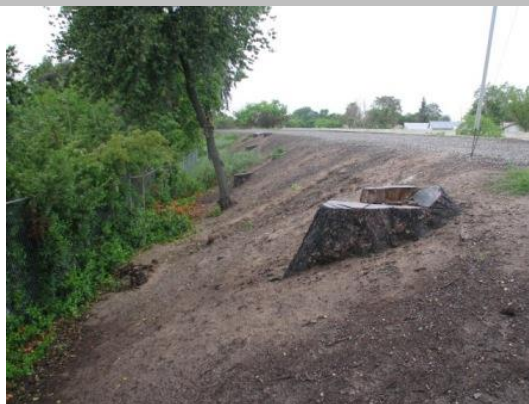
Photo 1 of 1 : SP_2018_NA0001_51_56_20180404_00035.jpg

Several large stumps on levee slope.

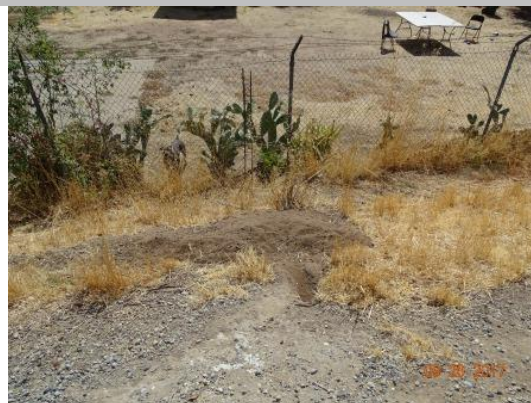
Photo 1 of 1 : SP_2018_NA0001_51_11_20180404_00010.jpg

View of the rodent activity on the levee slope.

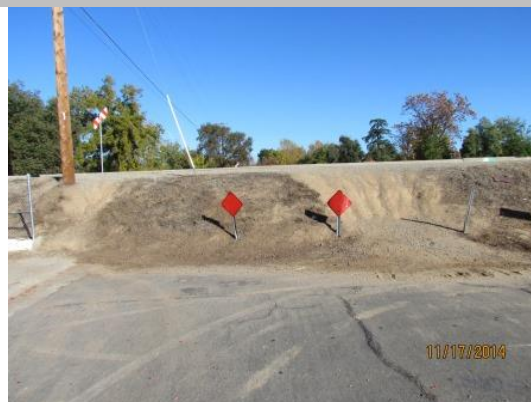
Photo 1 of 1 : SP_2018_NA0001_51_54_20180404_00034.jpg

LM Start	1.58	Rating **	A/W	Issue No.	54
LM End	1.58	Issue Type +	Ma	Location *	LS
Category	Earthen Levee			GPS Latitude/Longitude	
				Start	End
Item	Slope Stability			38.627251 °	38.627251 °
				-121.441460 °	-121.441460 °
DWR ID	DWR_NA0001_01_s_2012_54				
Comment Code					
S2 : Repair the levee slope damaged by foot traffic and prevent access where possible.					
Inspector Comment

Slope stability due to foot traffic needs to be monitored.

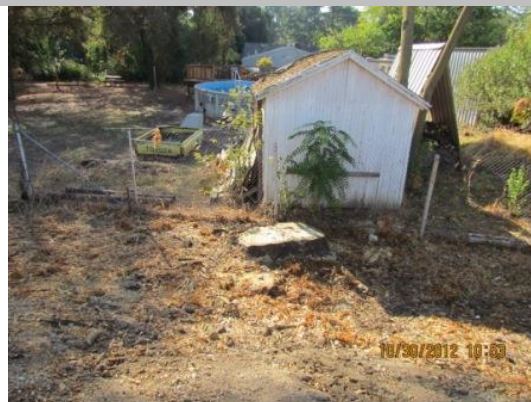
Photo 1 of 1 : SP_2018_NA0001_51_31_20180404_00025.jpg

LM Start	1.61	Rating **	N	Issue No.	31
LM End	1.61	Issue Type +	Ma	Location *	LS
Category	Earthen Levee			GPS Latitude/Longitude	
				Start	End
Item	Trim / Thin Trees			38.627191 °	38.627191 °
				-121.440861 °	-121.440861 °
DWR ID	DWR_NA0001_01_f_2012_31				
Comment Code					
T5 : Tree stumps.					
Inspector Comment

View of large tree stump at levee toe.

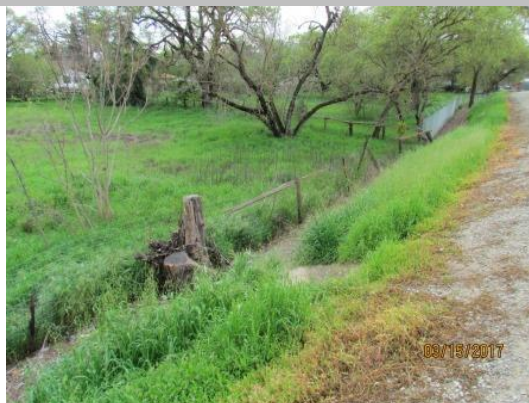
Photo 1 of 1 : SP_2018_NA0001_51_74_20180404_00047.jpg

View of the tree stump at the levee toe.

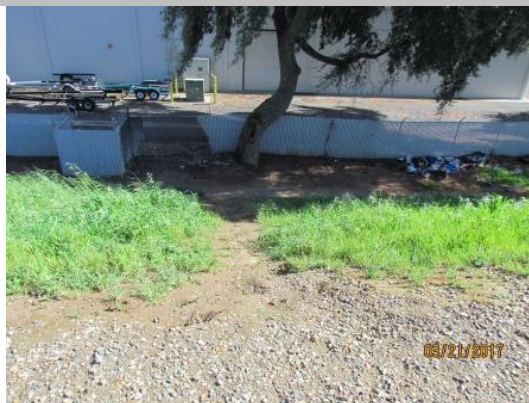
Photo 1 of 1 : SP_2018_NA0001_52_19_20180404_00005.jpg

View of the stairs dug into the landside levee slope.

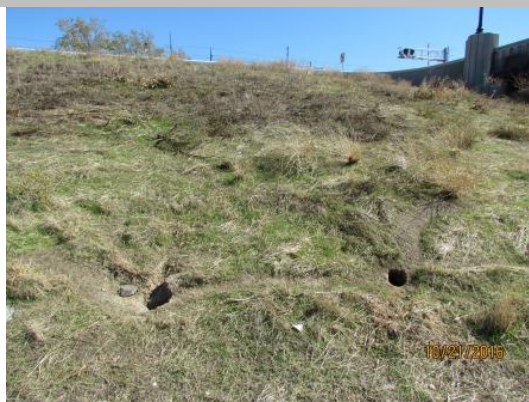
Photo 1 of 1 : SP_2018_NA0001_52_24_20180404_00006.jpg

LM Start	0.73	Rating **	M	Issue No.	24	
LM End	0.73	Issue Type +	Ma	Location *	WS	
Category	Earthen Levee			GPS Latitude/Longitude		
				Start	End	
Item	Animal Control			38.611529 °	38.611529 °	
				-121.466801 °	-121.466801 °	
DWR ID	DWR_NA0001_02_s_2016_24					
Comment Code						
A1 : Exterminate rodents and backfill and compact or grout burrows.						
Inspector Comment						
Rodents still active in this area.

View of the rodent holes in the waterside levee slope.

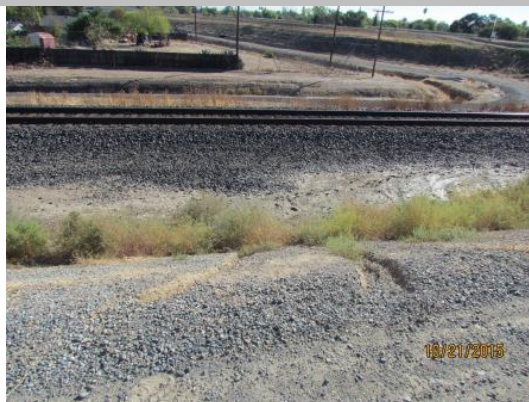
Photo 1 of 1 : SP_2018_NA0001_52_26_20180404_00008.jpg

LM Start	1.40	Rating **	M	Issue No.	26
LM End	1.40	Issue Type +	Ma	Location *	LS
Category	Earthen Levee			GPS Latitude/Longitude	
				Start	End
Item	Slope Stability			38.621054 °	38.621054 °
				-121.468008 °	-121.468008 °
DWR ID	DWR_NA0001_02_f_2015_26				
Comment Code					
S3 : Repair the levee slope damaged by vehicle traffic and prevent access where possible.					
Inspector Comment

View of the damaged landside levee slope.

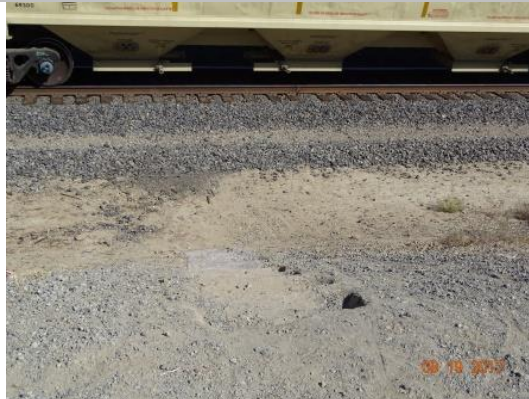
Photo 1 of 1 : SP_2018_NA0001_52_1_20180404_00001.jpg

View of the unpermitted steps in the levee.

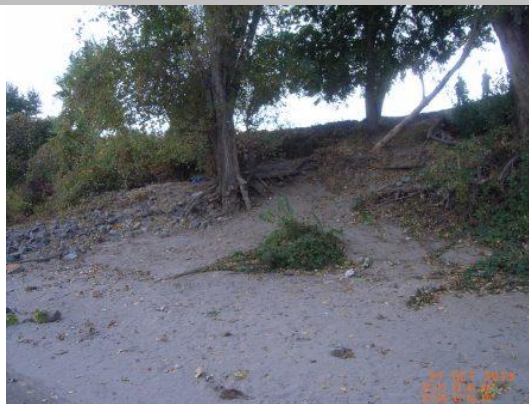
Photo 1 of 1 : SP_2018_NA0001_55_7_20180508_00008.jpg

LM Start	1.61	Rating **	M	Issue No.	7
LM End	1.65	Issue Type +	Ma	Location *	WS
Category	Supplemental			GPS Latitude/Longitude	
				Start	End
Item	2015 USACE Erosion Survey, DRAFT			38.599095 °	38.598791 °
				-121.480337 °	-121.479799 °
DWR ID	DWR_NA0001_04_s_2016_7				
Comment Code					
Inspector Comment					
2012 - Located just downstream of older repair. Failing rock at the upstream end. Erosion of the bank has exposed large tree roots. 2015: No observed changes. [2015 Site ID: LAR_1-8_L]

USACE 2013 Photo #1

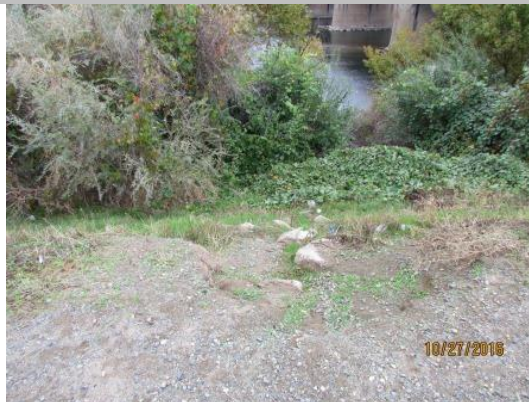
Photo 1 of 2 : SP_2018_NA0001_55_250_20180508_00200.jpg

LM Start	1.85	Rating **	A/W	Issue No.	250
LM End	1.85	Issue Type +	Ma	Location *	WS
Category	Earthen Levee			GPS Latitude/Longitude	
				Start	End
Item	Slope Stability			38.596220 °	38.596220 °
				-121.477713 °	-121.477713 °
DWR ID	DWR_NA0001_04_s_2016_250				
Comment Code					
S2 : Repair the levee slope damaged by foot traffic and prevent access where possible.					
Inspector Comment					
The erosion of the levee slope from the footpath appears to be stable at this time and should be monitored.

View of the footpath on the waterside levee slope, looking at the slope.

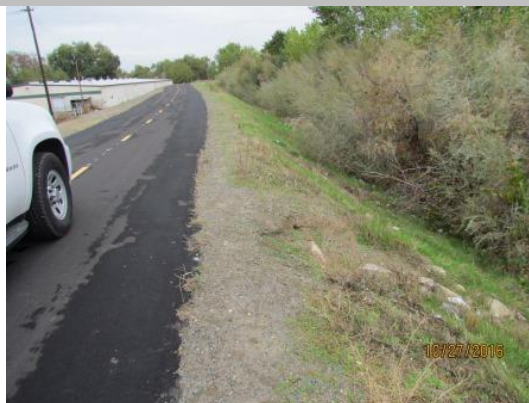
Photo 2 of 2 : SP_2018_NA0001_55_250_20180508_00201.jpg

LM Start	1.85	Rating **	A/W	Issue No.	250 (cont)
LM End	1.85	Issue Type +	Ma	Location *	WS
Category	Earthen Levee			GPS Latitude/Longitude	
				Start	End
Item	Slope Stability			38.596220 °	38.596220 °
				-121.477713 °	-121.477713 °
DWR ID	DWR_NA0001_04_s _ 2016_250				
Comment Code					
S2 : Repair the levee slope damaged by foot traffic and prevent access where possible.					
Inspector Comment					
The erosion of the levee slope from the footpath appears to be stable at this time and should be monitored.

View of the footpath on the waterside levee slope, looking downstream.

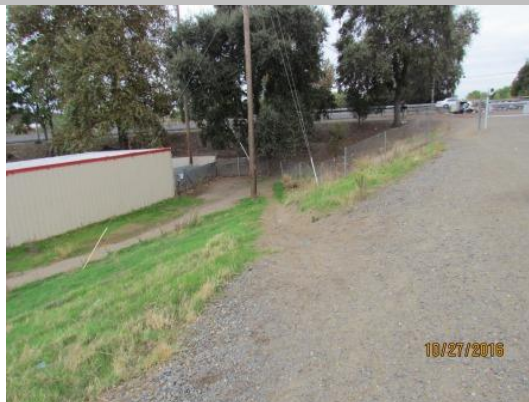
Photo 1 of 1 : SP_2018_NA0001_55_244_20180508_00195.jpg

LM Start	1.95	Rating **	A/W	Issue No.	244
LM End	1.95	Issue Type +	Ma	Location *	LS
Category	Earthen Levee			GPS Latitude/Longitude	
				Start	End
Item	Slope Stability			38.595040 °	38.595040 °
				-121.476882 °	-121.476882 °
DWR ID	DWR_NA0001_04_f_2015_244				
Comment Code					
S2 : Repair the levee slope damaged by foot traffic and prevent access where possible.					
Inspector Comment					
The erosion of the levee slope from the footpath appears to be stable at this time and should be monitored.

View of the footpath on the landside levee slope.

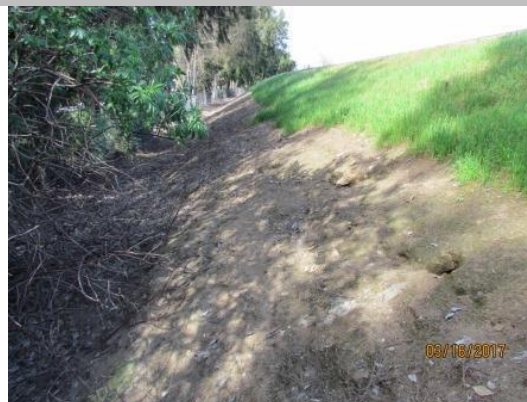
Photo 1 of 1 : SP_2018_NA0001_55_260_20180508_00204.jpg

View of the rodent burrows at the levee toe.

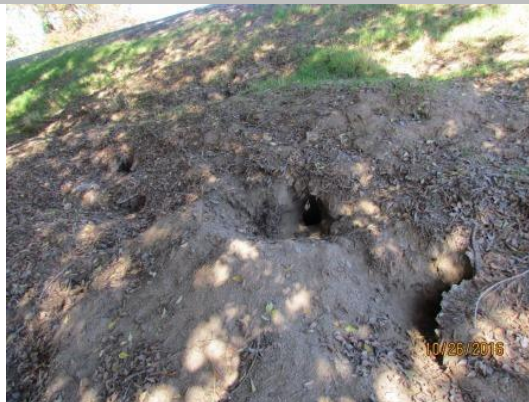
Photo 1 of 2 : SP_2018_NA0001_55_240_20180508_00192.jpg

View of a rodent burrows at the landside levee toe.

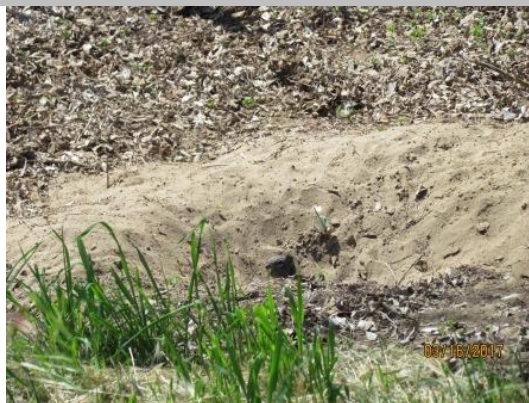
Photo 2 of 2 : SP_2018_NA0001_55_240_20180508_00193.jpg

Another view of the rodent burrow at the levee toe.

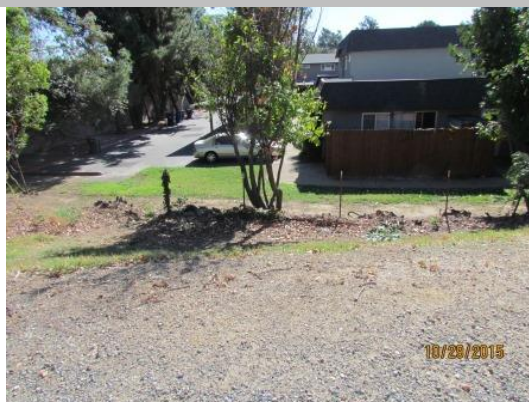
Photo 1 of 1 : SP_2018_NA0001_55_230_20180508_00186.jpg

View of the multiple tree stumps at the landside levee toe.

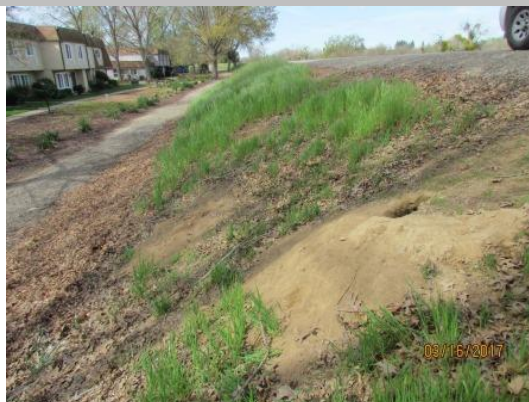
Photo 1 of 2 : SP_2018_NA0001_55_249_20180508_00198.jpg

View of the rodent burrows on the levee slope, looking upstream.

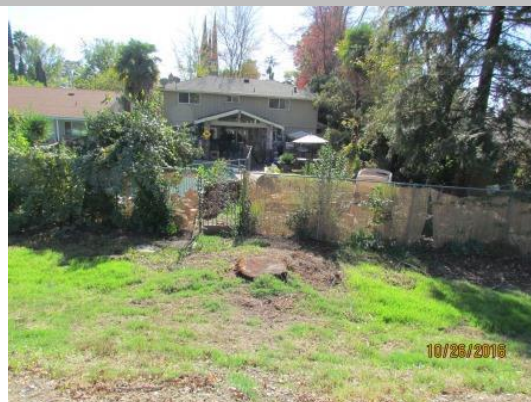
Photo 1 of 1 : SP_2018_NA0001_55_222_20180508_00179.jpg

View of the tree stump at the landside levee toe.

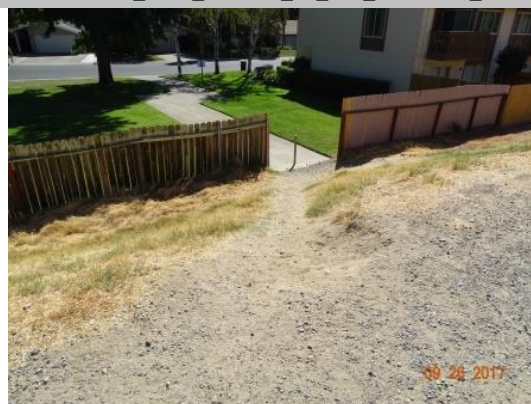
Photo 1 of 1 : SP_2018_NA0001_55_228_20180508_00185.jpg

LM Start	10.42	Rating **	A/W	Issue No.	228
LM End	10.42	Issue Type +	Ma	Location *	LS
Category	Earthen Levee			GPS Latitude/Longitude	
				Start	End
Item	Slope Stability			38.570536 °	38.570536 °
				-121.354957 °	-121.354957 °
DWR ID	DWR_NA0001_04_s_2016_228				
Comment Code					
S2 : Repair the levee slope damaged by foot traffic and prevent access where possible.					
Inspector Comment					
The erosion of the levee slope from the footpath appears to be stable at this time and should be monitored.

View of the footpath on the levee slope.

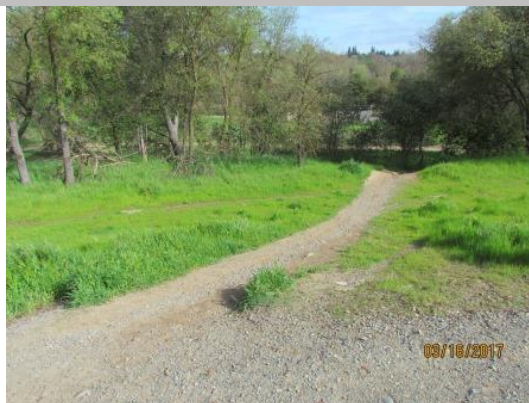
Photo 1 of 1 : SP_2018_NA0001_55_219_20180508_00178.jpg

LM Start	10.44	Rating **	A/W	Issue No.	219
LM End	10.44	Issue Type +	Ma	Location *	WS
Category	Earthen Levee			GPS Latitude/Longitude	
				Start	End
Item	Slope Stability			38.570559 °	38.570559 °
				-121.354514 °	-121.354514 °
DWR ID	DWR_NA0001_04_s _ 2017_219				
Comment Code					
S2 : Repair the levee slope damaged by foot traffic and prevent access where possible.					
Inspector Comment					
The erosion of the levee slope from the footpath appears to be stable at this time and should be monitored.

View of the footpath on the levee slope.

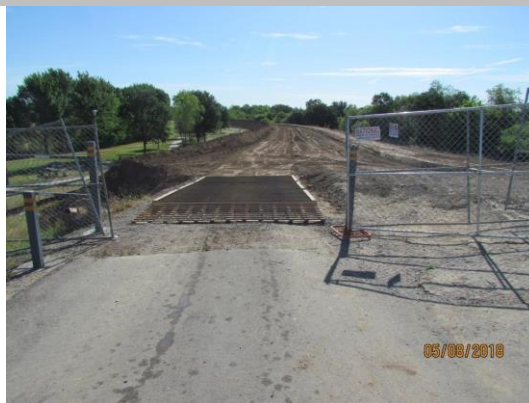
Photo 1 of 1 : SP_2018_NA0001_58_32_20180514_00048.jpg

LM Start	0.01	Rating **	A/W	Issue No.	32
LM End	1.92	Issue Type +	Ma	Location *	CR
Category	Earthen Levee			GPS Latitude/Longitude	
				Start	End
Item	Crown Surface / Depressions / Rutting			38.620443 °	38.628500 °
				-121.467664 °	-121.436135 °
DWR ID	DWR_NA0001_07_s_2018_32				
Comment Code					
C2 : Repair depressions or ruts in the crown or slope.					
Inspector Comment					
This Unit is under construction and not accessible. All the issues for Unit 7 will have to be reassessed when construction is complete and turn back over to ARFCD to maintain. Spring 2018.

View looking upstream from Norwood Ave. This Unit is under construction and not accessible. All the issues for Unit 7 will have to be reassessed when construction is complete and turn back over to ARFCD to maintain. Spring 2018.

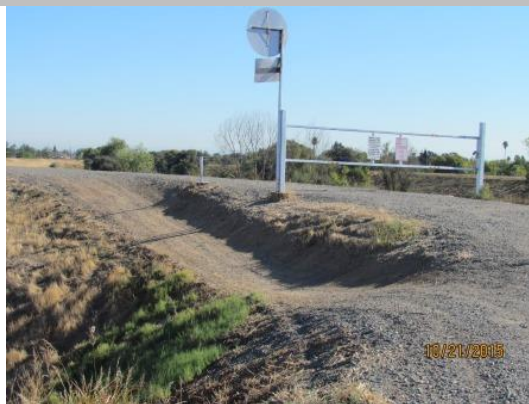
Photo 1 of 1 : SP_2018_NA0001_58_38_20180404_00030.jpg

LM Start	0.04	Rating **	M	Issue No.	38
LM End	0.04	Issue Type +	Ma	Location *	LS
Category	Earthen Levee			GPS Latitude/Longitude	
				Start	End
Item	Slope Stability			38.620569 °	38.620569 °
				-121.467117 °	-121.467117 °
DWR ID	DWR_NA0001_07_f_2015_38				
Comment Code					
S3 : Repair the levee slope damaged by vehicle traffic and prevent access where possible.					
Inspector Comment

View of the landside levee slope damaged by motorized traffic.

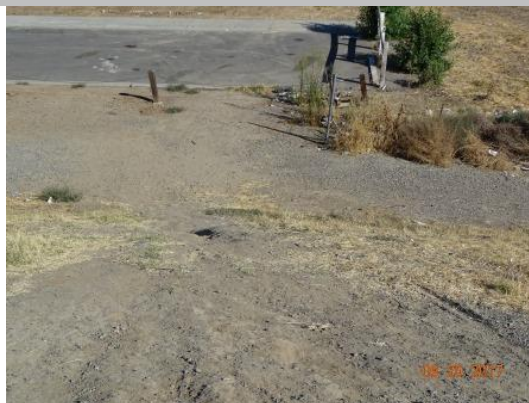
Photo 1 of 1 : SP_2018_NA0001_58_5_20180404_00004.jpg

LM Start	1.05	Rating **	A/W	Issue No.	5
LM End	1.05	Issue Type +	Ma	Location *	LS
Category	Earthen Levee			GPS Latitude/Longitude	
				Start	End
Item	Slope Stability			38.625862 °	38.625862 °
				-121.450978 °	-121.450978 °
DWR ID	DWR_NA0001_07_f_2017_5				
Comment Code					
S2 : Repair the levee slope damaged by foot traffic and prevent access where possible.					
Inspector Comment					
Minor erosion on the slope should be monitored.

View of the damaged levee slope.

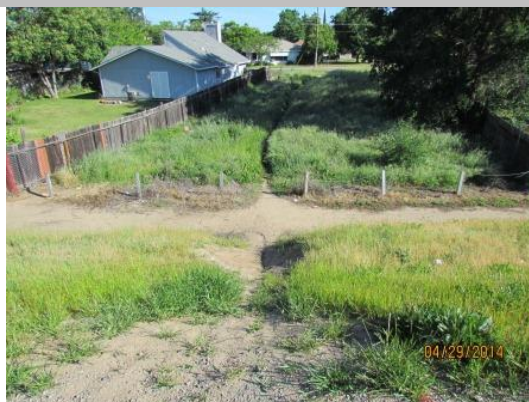
Photo 1 of 1 : SP_2018_NA0001_58_34_20180404_00028.jpg

LM Start	1.39	Rating **	A/W	Issue No.	34
LM End	1.39	Issue Type +	Ma	Location *	LS
Category	Earthen Levee			GPS Latitude/Longitude	
				Start	End
Item	Slope Stability			38.626601 °	38.626601 °
				-121.445016 °	-121.445016 °
DWR ID	DWR_NA0001_07_s_2012_34				
Comment Code					
S2 : Repair the levee slope damaged by foot traffic and prevent access where possible.					
Inspector Comment					
The erosion of the levee slope from the footpath appears to be stable at this time and should be monitored.

View of the landside levee slope damaged by foot traffic.

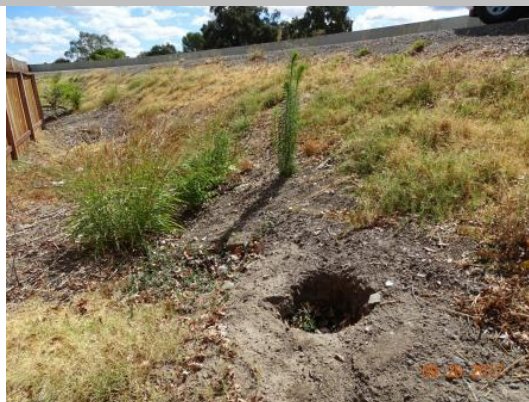
Photo 1 of 1 : SP_2018_NA0001_58_18_20180404_00017.jpg

View of the rodent hole that needs to be backfilled.

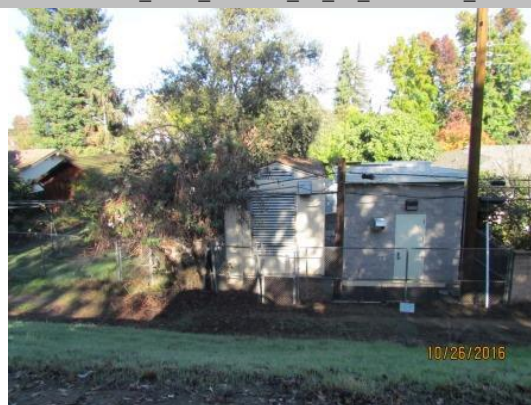
Photo 1 of 1 : SP_2018_NA0001_60_14_20180404_00005.jpg

Tree trunk at fence line.

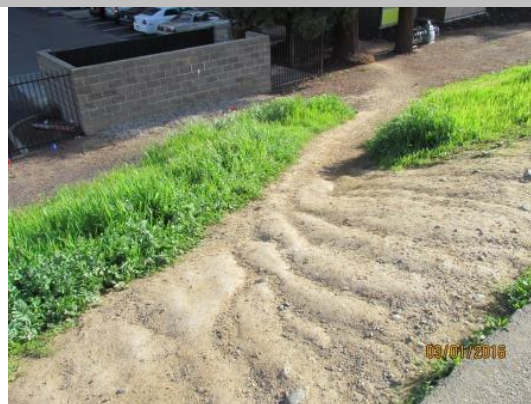
Photo 1 of 1 : SP_2018_NA0001_60_28_20180404_00010.jpg

LM Start	1.88	Rating **	M	Issue No.	28
LM End	1.88	Issue Type +	Ma	Location *	LS
Category	Earthen Levee			GPS Latitude/Longitude	
				Start	End
Item	Slope Stability			38.561171 °	38.561171 °
				-121.415808 °	-121.415808 °
DWR ID	DWR_NA0001_09_s_2016_28				
Comment Code					
S2 : Repair the levee slope damaged by foot traffic and prevent access where possible.					
Inspector Comment

View of the landside levee slope.

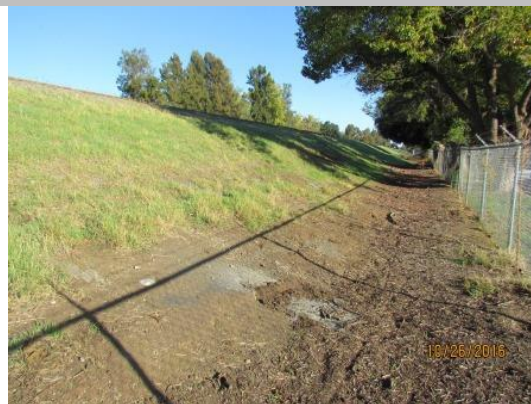
Photo 1 of 2 : SP_2018_NA0001_60_27_20180404_00008.jpg

View of the rodent holes on the landside levee slope.

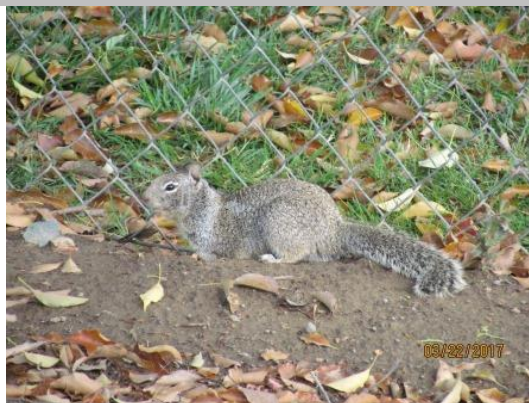
Photo 2 of 2 : SP_2018_NA0001_60_27_20180404_00009.jpg

View of the rodent at the levee toe causing levee damage.

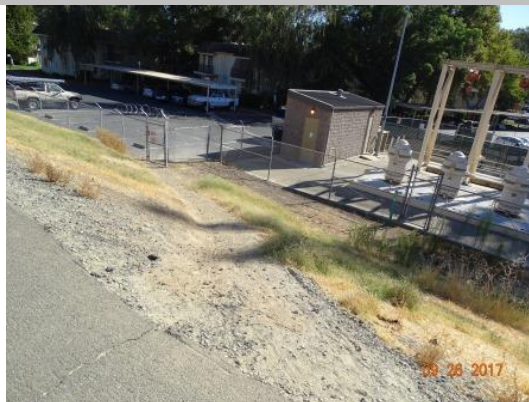
Photo 1 of 1 : SP_2018_NA0001_60_9_20180404_00004.jpg

LM Start	2.73	Rating **	A/W	Issue No.	9
LM End	2.73	Issue Type +	Ma	Location *	LS
Category	Earthen Levee			GPS Latitude/Longitude	
				Start	End
Item	Slope Stability			38.571868 °	38.571868 °
				-121.420605 °	-121.420605 °
DWR ID	DWR_NA0001_09_s_2018_9				
Comment Code					
S2 : Repair the levee slope damaged by foot traffic and prevent access where possible.					
Inspector Comment					
Footpath appears to be stable at this time but should be monitored for further erosion.

View of the footpath on the levee slope.

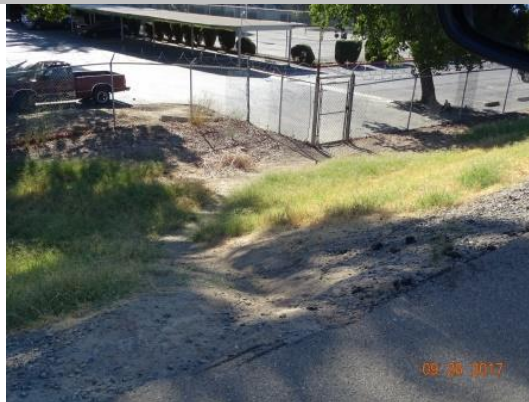
Photo 1 of 1 : SP_2018_NA0001_60_8_20180404_00003.jpg

LM Start	2.92	Rating **	M	Issue No.	8
LM End	2.92	Issue Type +	Ma	Location *	LS
Category	Earthen Levee			GPS Latitude/Longitude	
				Start	End
Item	Slope Stability			38.574474 °	38.574474 °
				-121.419734 °	-121.419734 °
DWR ID	DWR_NA0001_09_f_2017_8				
Comment Code					
S2 : Repair the levee slope damaged by foot traffic and prevent access where possible.					
Inspector Comment

View of the footpath on the levee slope.

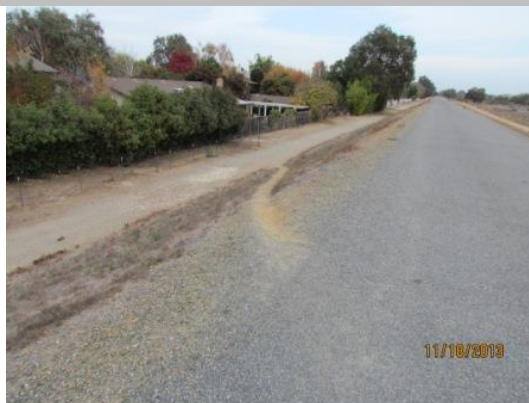
Photo 1 of 1 : SP_2018_NA0001_61_7_20180404_00002.jpg

View of the pathway on the landside levee slope.

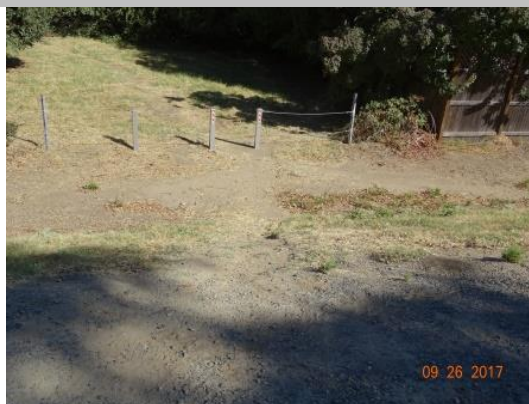
Photo 1 of 1 : SP_2018_NA0001_61_2_20180404_00001.jpg

View of the footpath on the levee slope.

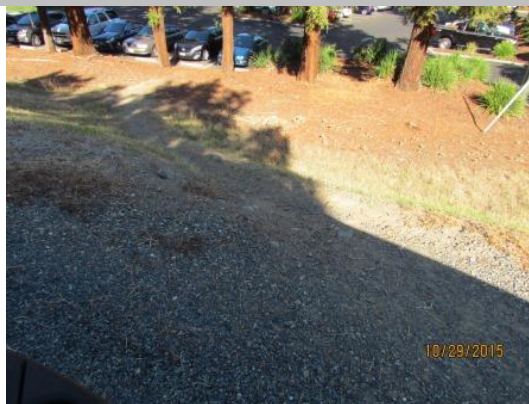
Photo 1 of 1 : SP_2018_NA0001_61_21_20180404_00004.jpg

View of the footpath on the landside levee slope.

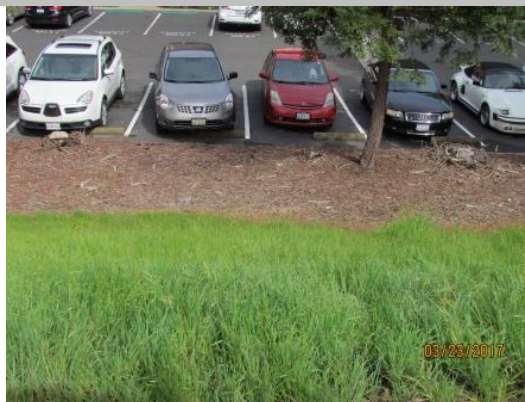
Photo 1 of 1 : SP_2018_NA0001_61_29_20180404_00008.jpg

View of the tree stump within the levee easement.

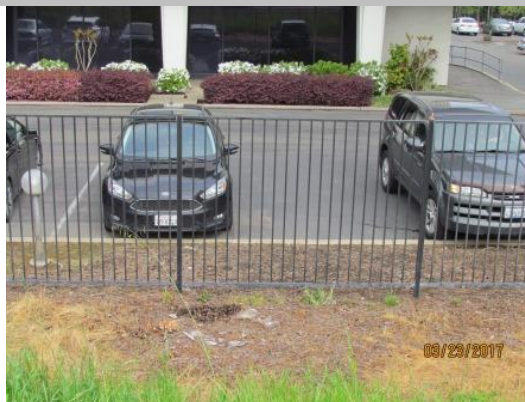
Photo 1 of 1 : SP_2018_NA0001_61_28_20180404_00007.jpg

View of the tree stump at the levee toe.
